OPERATION PLUMBBOB

NEVADA TEST SITE
MAY-OCTOBER 1957

Project 30.7

TEST OF GERMAN UNDERGROUND
PERSONNEL SHELTERS

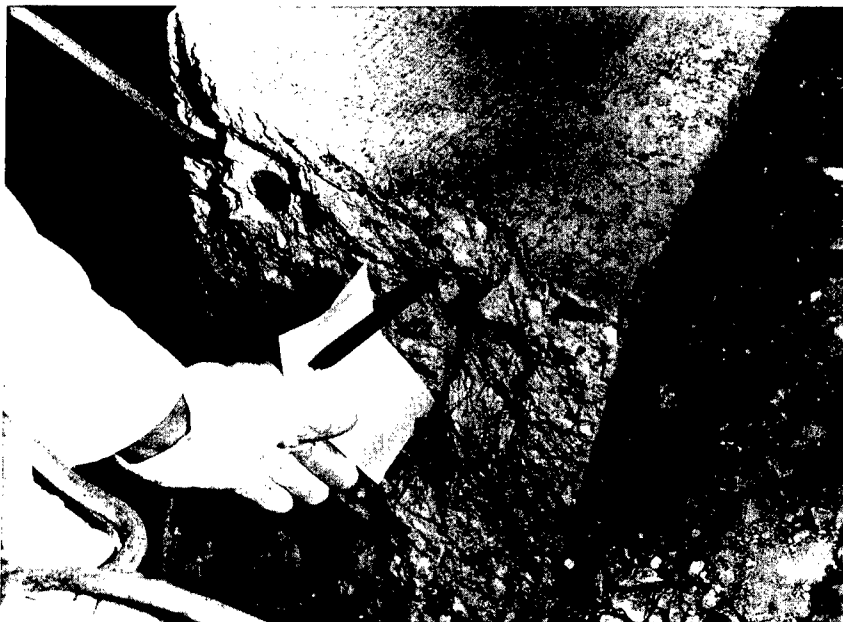
(a) *Entranceways.* In the ramp entrance facing GZ separations formed at the intersections of the interior and exterior walls with the ramp slab. The interior wall was pulled away from the slab 7 in. at the bottom and $\frac{1}{16}$ in. at the top of the ramp. The intersection of the ramp and exterior wall was similar to that at the interior wall; that is, the crack varied from 4 to 7 in. near the bottom to zero inches at the top of the ramp. Bowing of the interior wall into the backfill was produced at the quarter-height along the contraction joint. A $\frac{1}{16}$ - to $\frac{1}{2}$ -in. vertical crack was formed near the bottom of the ramp. This crack terminated at a laminated area located at the mid-height of the wall. There was spalling on both sides at the upper section of the crack. Cracks varying from $\frac{1}{16}$ to $\frac{3}{8}$ in. in width, perpendicular to the plane of the ramp, were located approximately 2 ft on center along the length of the wall. The majority of these cracks ran the full height of the wall. A crack starting at a chipped-out section located at the intersection of the end of the roof slab and the interior wall ran diagonally toward the top of the wall. The section of the wall above this crack was deflected back into the fill. The exterior wall damage was similar to that described for the interior wall. A chipped section of the exterior ramp wall was located approximately 4 ft above the landing at the contraction joint. A horizontal crack, with spalling on both sides, above this section produced a $\frac{1}{2}$ -in. bow in this wall. There were numerous diagonal cracks perpendicular to the plane of the ramp located approximately 2 to 3 ft on center in the upper two-thirds of wall. These cracks varied in size from $\frac{1}{32}$ to 1 in. in width. The top of the parapet located above the landing roof slab that faces GZ was deflected into the backfill 6 in. at the intersection of the exterior wall and 1 ft at the interior wall. The corners of the parapet and side walls were chipped, and the reinforcement was exposed.

Fig. 3.21—Detail of necked-down reinforcement torn from interior wall at parapet (structure RAa).

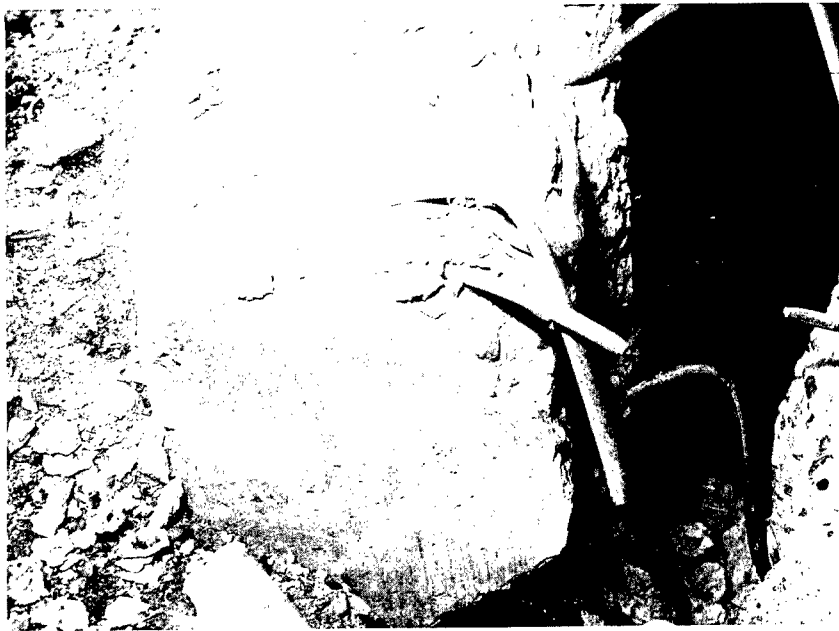
Fig. 3.22—Detail of exposed reinforcement after chipping at corner of interior wall and parapet facing toward GZ (structure RAa).

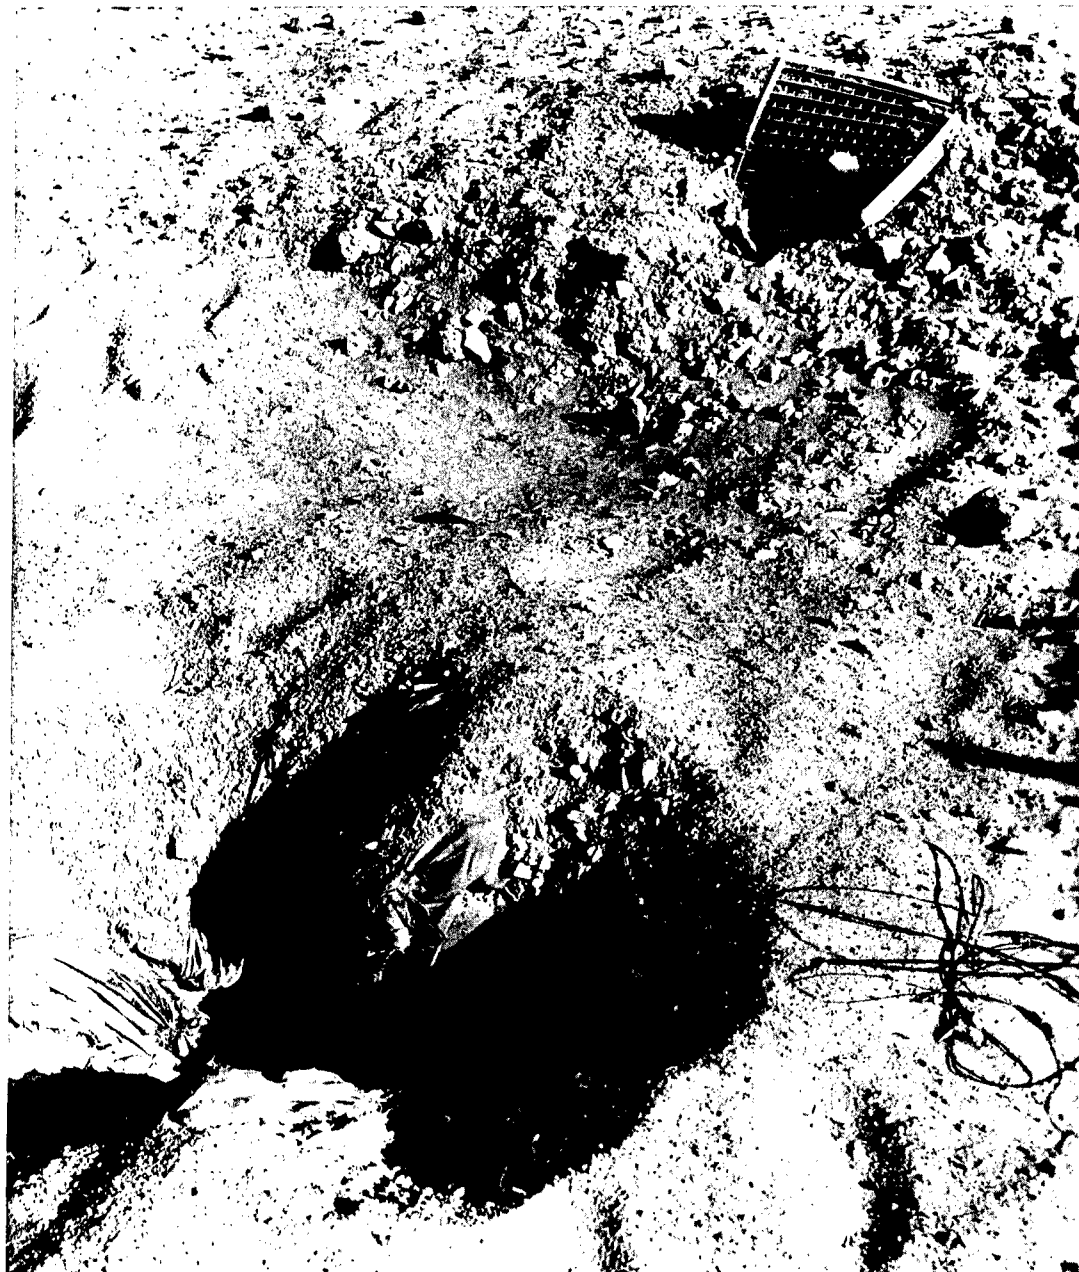
The emergency-exit hatch cover was blown down into the exit tunnel and deposited opposite the small blast door. The exit hatch cover showed no other damage except straightening of the hinge support straps. The releasing mechanism was also undamaged.

Fig. 3.24—Emergency-exit shaft (structure RAa).

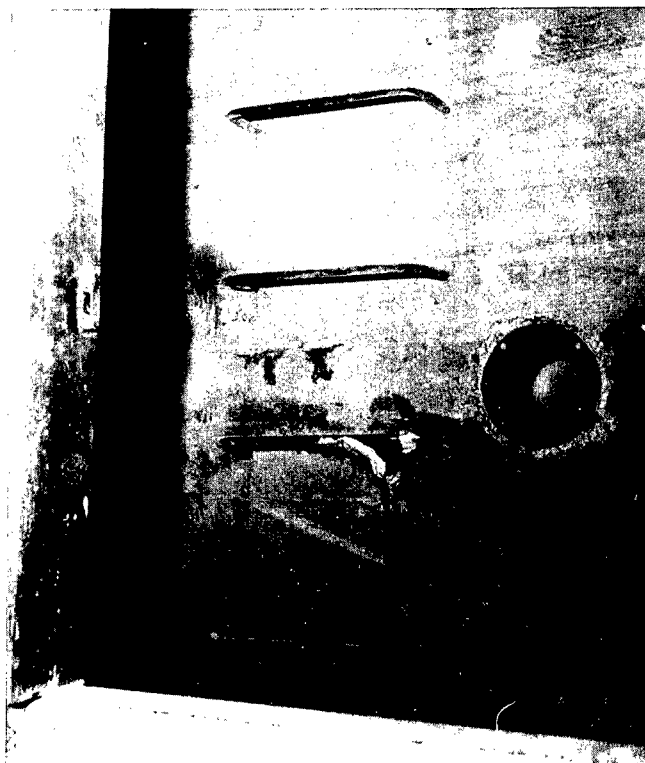
Fig. 3.67—Emergency-exit shaft from chamber between small blast and gastight doors (structure CAa).

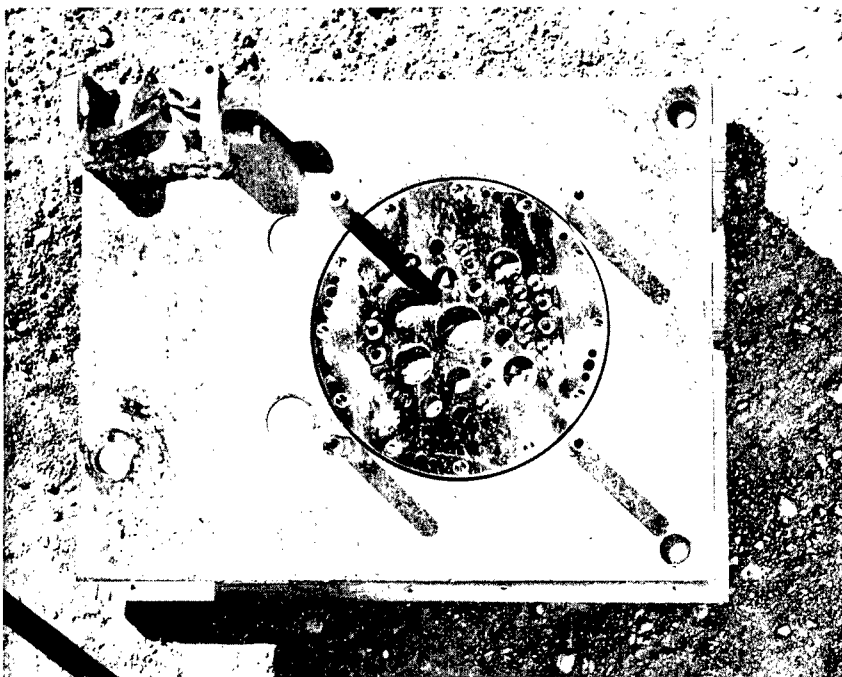
Fig. 3.113—Detail of German gauge No. 2
